HYUNDAI Technical Service Bulletin

Group	1/29/04 CAMPAIGN
Number	03-01-007
Date	JUNE, 2003
Model	1995 - 1996 ACCENT

**FRONT SUSPENSION
LOWER CONTROL ARM CORROSION -
CAMPAIGN 058**

This bulletin provides a procedure to inspect for, and if necessary, correct corrosion damage to the front suspension lower control arms.

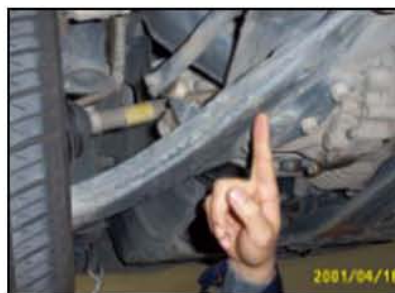
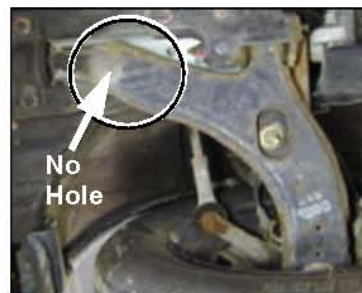
VEHICLE REQUIRES INSPECTION

- If the vehicle's lower control arms contain a hole in the lower surface as shown in the photograph, no further action is required (vehicle is not affected by this campaign).
- Lower the vehicle. The vehicle may be returned to the owner.
- If the vehicle's lower control arms do not contain a hole in the lower surface, proceed to the next steps to inspect the lower arms for corrosion (vehicle is affected by this campaign).

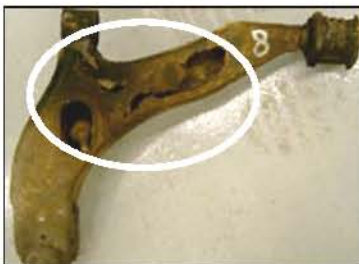
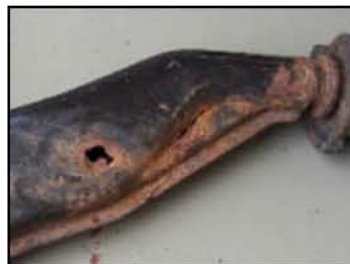
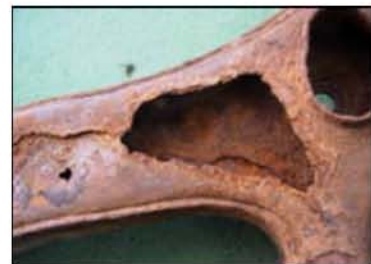
- If corrosion perforation or pinholes are observed in any lower control arm as shown, proceed to the "Lower control arm replacement procedure" on page 16 of this bulletin.

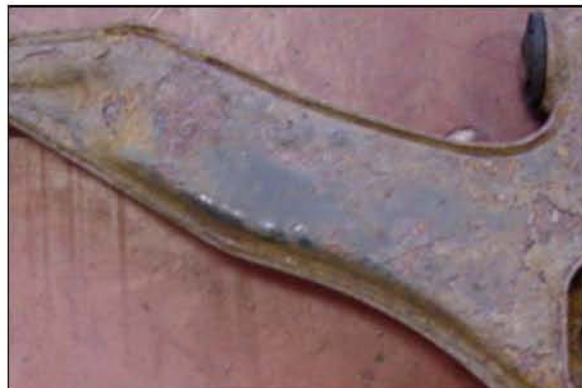
- If a light surface corrosion is observed without any perforation or pinholes, proceed to the next steps for further inspection of the upper surfaces of the arms.

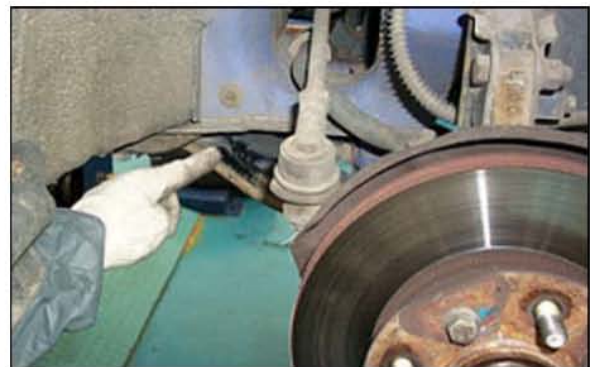
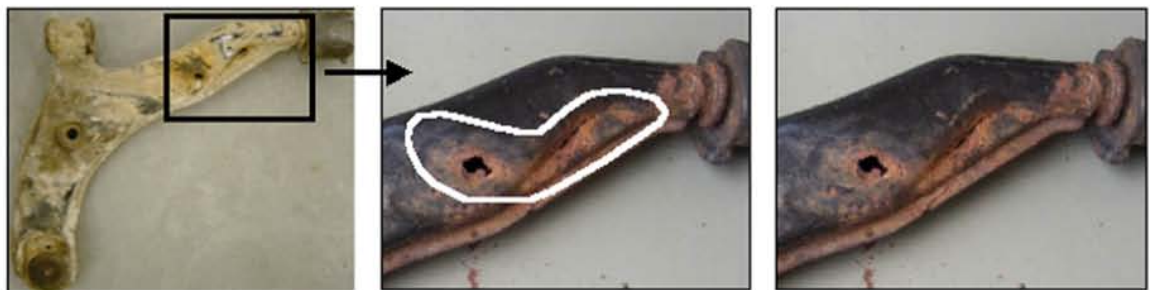
- If corrosion perforation or pinholes are observed in any lower control arm as shown, proceed to the "Lower control arm replacement procedure" on page 16 of this bulletin.

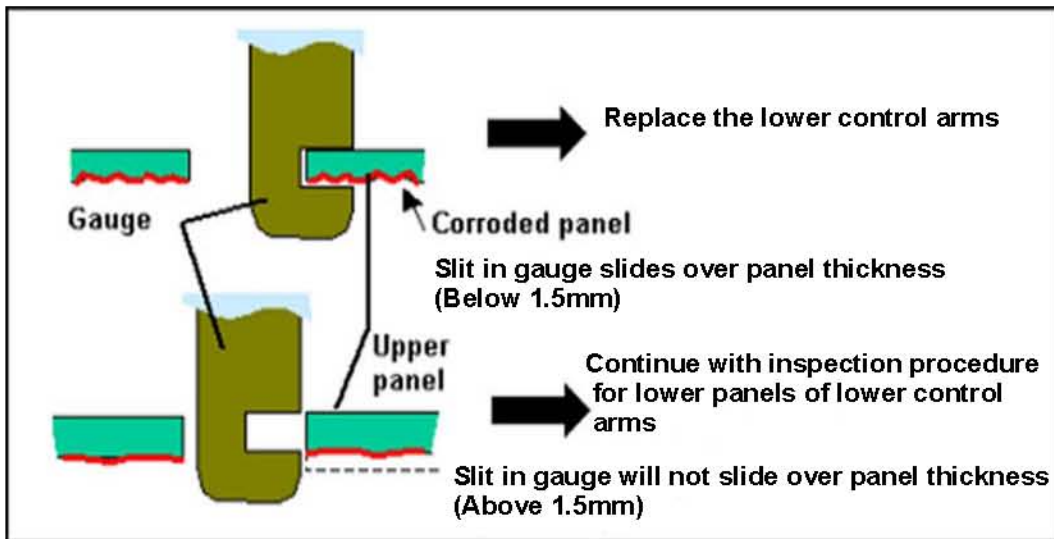
- If the 1.5 mm slit in the gauge can slide over any of the upper panels of the lower control arms, proceed to the "Lower control arm replacement procedure" on page 16 of this bulletin.
- If the 1.5 mm slit in the gauge cannot be slid over any upper panels, the upper panels of the lower control arms on both sides are acceptable.
- Continue with the next steps to check the integrity of the lower panels of both lower control arms.

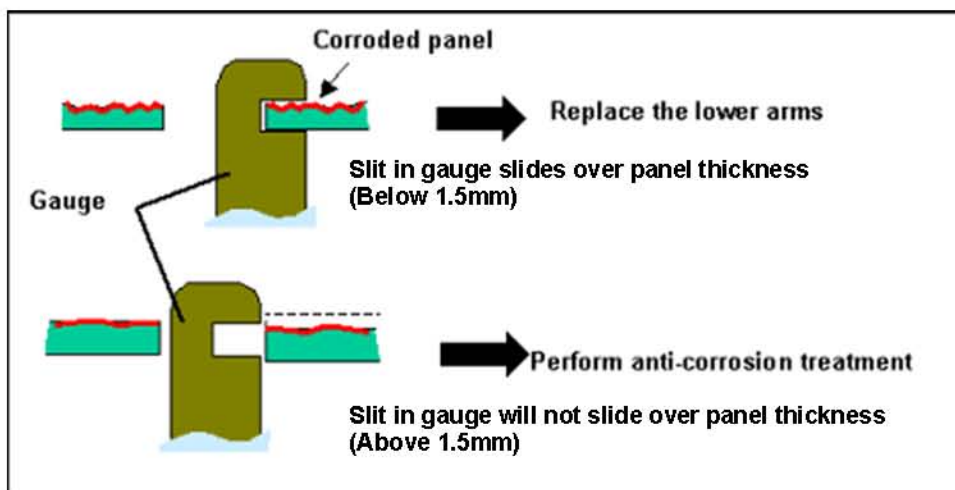
- If the 1.5 mm slit in the gauge can slide over any of the lower panels of the lower control arms, proceed to the "Lower control arm replacement procedure" on page 16 of this bulletin.
- If the 1.5 mm slit in the gauge cannot be slid over any lower panels, the lower panels of the lower control arms on both sides are acceptable.
- Perform the anti-corrosion treatment in steps 17 through 26:

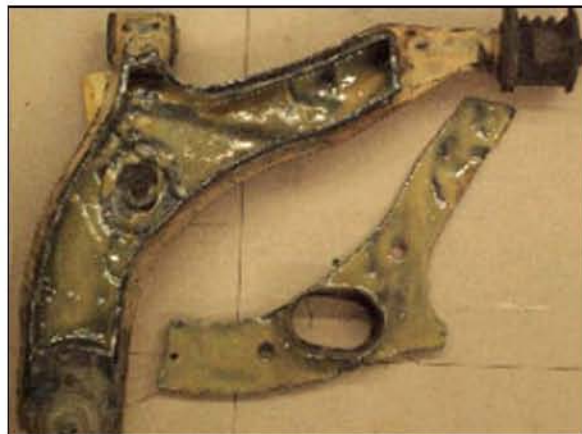
- Clean the spray gun and nozzle after spraying.
- The nozzle must be cleaned using thinner or solvent to prevent the wax in the nozzle from hardening.
- Internal view of lower control arm that has been treated with injected cavity wax.
