# Service Bulletin

Category S	Applicable Model/s 1996-97 B-Series	Subject <b>INSPECTION AND REPAIR PROCEDURES FOR OVERSPRAY CONCERNS</b>	Bulletin No. 053/96 Issued 12/12/96 Revised
---------------	--	---	---

## **B-SERIES TRUCK EXTERIOR PAINT OVERSPRAY CONTAMINATION INSPECTION/REPAIR PROCEDURE**

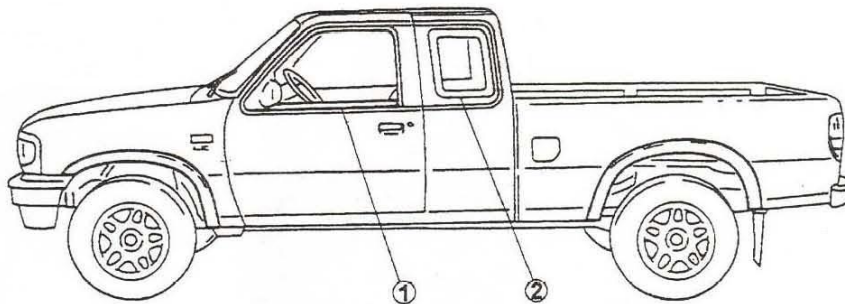
1. Place the vehicle in a well-lit area.
2. Wash and dry the bottom black trim area of the door ① and a portion of the driver's side "B" pillar black trim ②.

3. Inspect the cleaned area for small round white colored specks. These specks appear in a continuous pattern and are approximately 1 mm in diameter.
  - If the contamination is identified as overspray, proceed to the repair procedure.
  - If the contamination is other than overspray (i.e., rail dust or acid rain), repair as necessary using current policy and procedures.

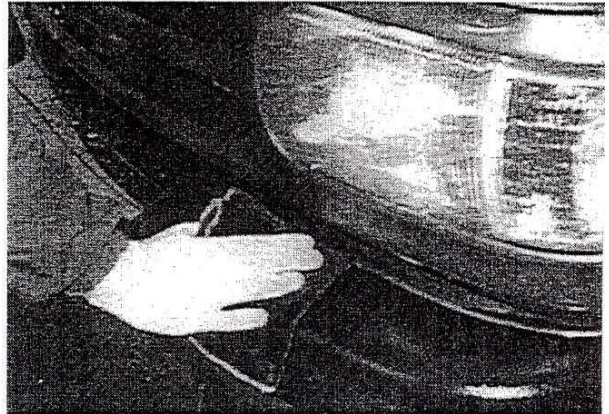
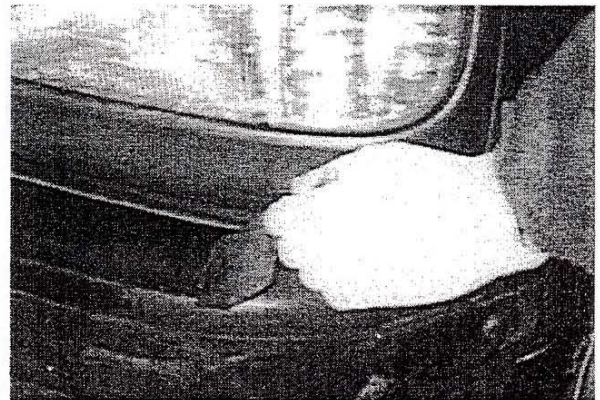
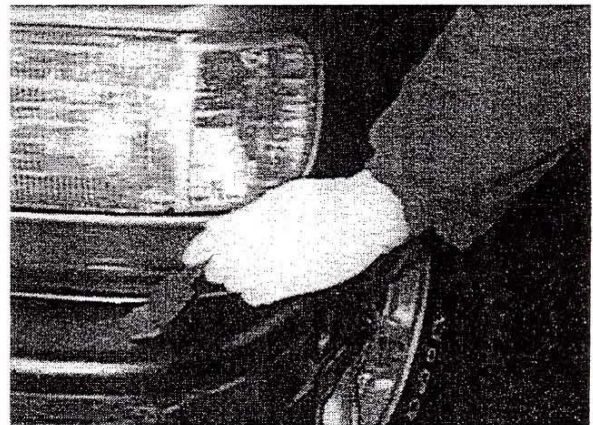
Since the overspray specks are very difficult to remove from textured surfaces, the affected parts (listed below) must be dyed. (Do not attempt soft rubber molding procedure on these parts.)

- Front and rear plastic bumper pads
  - Exterior mirror housing
  - Door handles
1. Clean the affected part with Prep Sol or a good quality grease remover and allow it to dry to the touch.

2. Using (E20) black sponge, apply an even coat of (ETR1 black) black dye to an affected part and allow it to dry to the touch. If necessary, repeat process to insure even coating and texture.

3. Using (E21) white sponge, apply an even coat of (ETR2 clear) gloss and UV protector and allow it to dry to the touch. Repeat this process on all affected parts as mentioned above.
