# Port Rework

2002 Millenia & Protégé 5 exterior paint contamination.

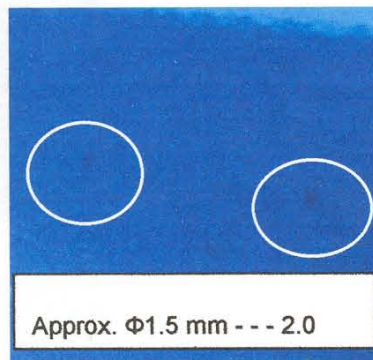
**Photos of the Black Colored Spots:**

Black colored spots may be imbedded into the vehicle's exterior surfaces that are not wrap guarded, wrap guarded surfaces were protected from the fall-out contamination. These spots are approx. 1. mm in diameter and are more visible on light colored vehicles. If the spots are not removed, a poor appearance of the vehicle's surfaces may result.

The vehicle(s) will first have to be washed, and then inspect the surfaces (that are not wrap guarded) for spot(s). If spot are noted, a three (3) step buffing and polishing procedure must be performed. The total chemical contents of the fall-out (spot) has not been determined, but no type of acid is present. Therefore, it is not necessary to neutralize the affected surfaces.
