HYUNDAI Technical Service Bulletin

Group	1/29/04 CAMPAIGN
Number	03-01-007
Date	JUNE, 2003
Model	1995 - 1996 ACCENT

**FRONT SUSPENSION
LOWER CONTROL ARM CORROSION -
CAMPAIGN 058**

This bulletin provides a procedure to inspect for, and if necessary, correct corrosion damage to the front suspension lower control arms.

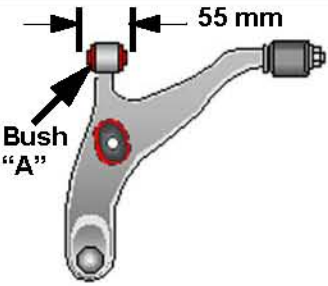
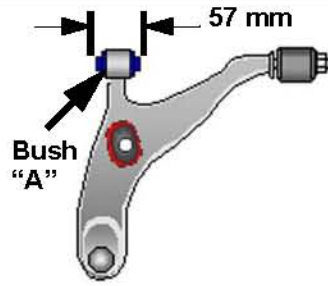
<p>FACTORY INSTALLED-PARTS</p> <p>(LOWER CONTROL ARM IDENTIFICATION ON VEHICLE)</p>	<p>PART NAME</p>	<p>LOWER CONTROL ARM ASSEMBLY</p>	
	<p>PRODUCTION DATE RANGE</p>	<p>JOB #1 ~ JUNE 15, 1996</p>	<p>JUNE 15, 1996 ~ AUGUST 31, 1996</p>
	<p>Difference in dimension (Bush "A")</p>

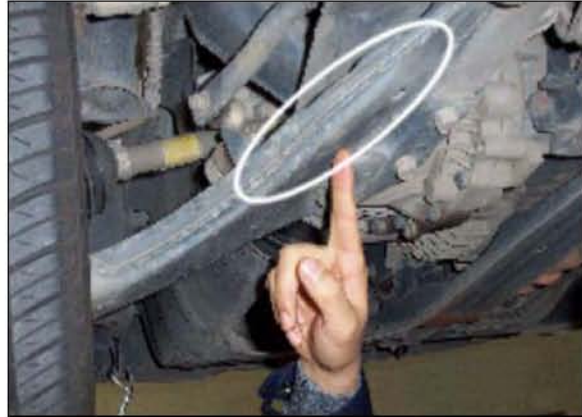
4. Check the lower surfaces of both lower control arms for any corrosion perforation.

- If corrosion perforation or pinholes are observed in any lower control arm as shown, proceed to the "Lower control arm replacement procedure" on page 16 of this bulletin.

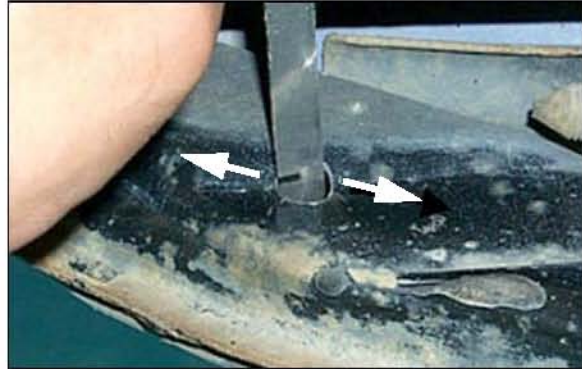
- Slide the slit portion in the gauge in the direction of the formed line on the upper panels of both lower control arms to measure the Go/ No-Go thickness at the two arrow locations.

- If the 1.5 mm slit in the gauge can slide over any of the upper panels of the lower control arms, proceed to the "Lower control arm replacement procedure" on page 16 of this bulletin.
- If the 1.5 mm slit in the gauge cannot be slid over any upper panels, the upper panels of the lower control arms on both sides are acceptable.
- Continue with the next steps to check the integrity of the lower panels of both lower control arms.

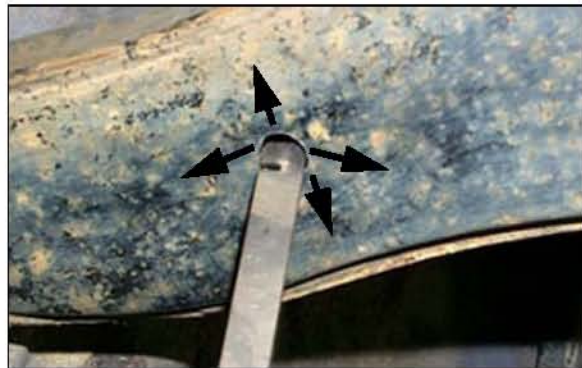
16. Slide the slit portion in the gauge in the direction of the formed lines on the lower panels of both lower control arms as shown to measure the Go/ No-Go thickness at the four arrow locations.

- If the 1.5 mm slit in the gauge can slide over any of the lower panels of the lower control arms, proceed to the "Lower control arm replacement procedure" on page 16 of this bulletin.
- If the 1.5 mm slit in the gauge cannot be slid over any lower panels, the lower panels of the lower control arms on both sides are acceptable.
- Perform the anti-corrosion treatment in steps 17 through 26:

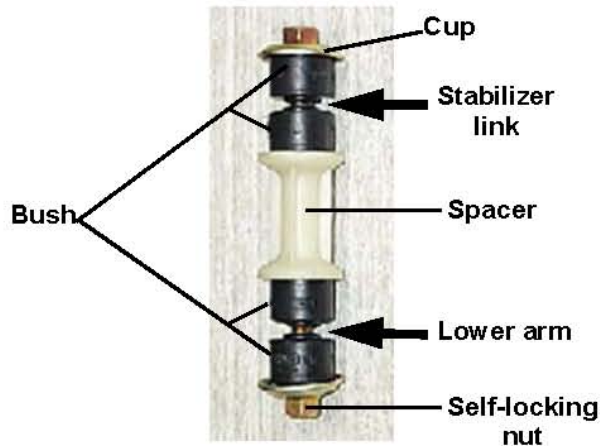
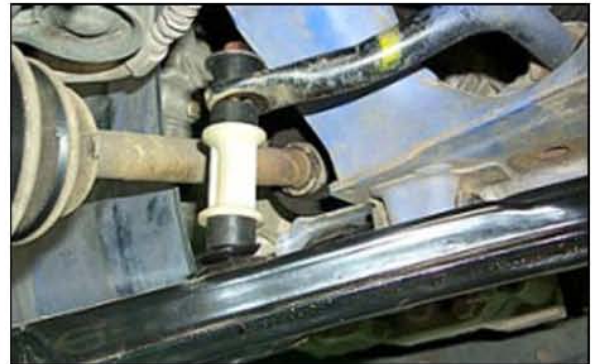
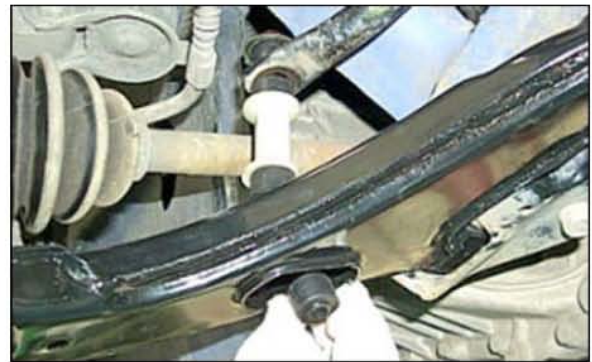
CAUTION: The stabilizer link bush is directional. The bushes must be inserted as shown below.

Gradually tighten self-locking nuts on left and right stabilizer links by turns.
