GROUP Service Campaign	MODEL Multiple Models (see below)
	NUMBER SC122	DATE July 2015
VOLUNTARY SERVICE CAMPAIGN		
SUBJECT: APPLICATION OF ADDITIONAL ANTI-CORROSION MATERIAL (SC122)

APPLICATION OF ADDITIONAL ANTI-CORROSION MATERIAL (SC122)

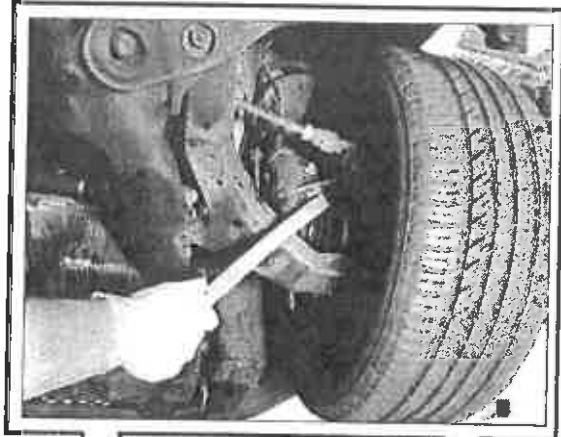
3. Use a metal bristle brush to clean and remove any rust scales or contaminants from all surfaces of each front lower control arm.

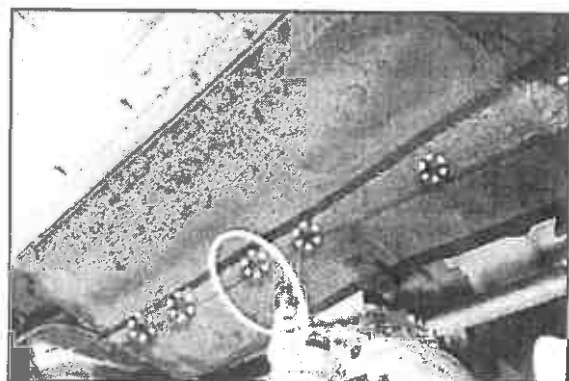
- On Spectra (LD) vehicles, remove five (5) rocker panel plugs on each side and apply cavity wax into every hole, as shown. **Note: make sure to vary the insertion angle of the nozzle to maximize coverage.**
- Additionally, apply cavity wax into every hole of the chassis rails, as shown. **NOTE: make sure to vary the insertion angle of the nozzle to maximize coverage.**

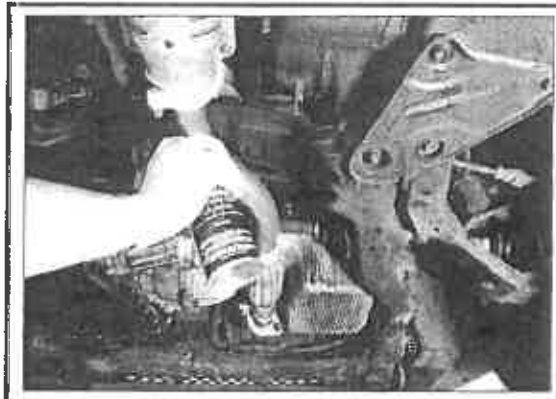
1. On all vehicles, apply undercoating onto the entire front subframe, as shown. Do **NOT** apply undercoating to the exhaust pipe or other unrelated parts of the vehicle.

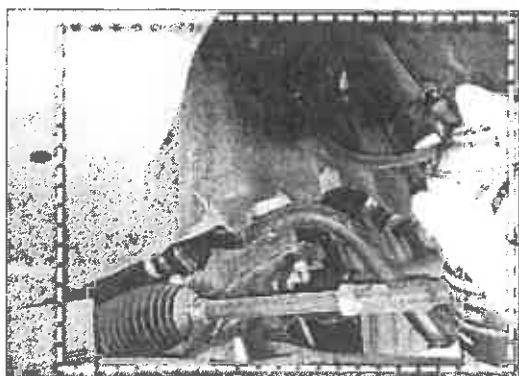
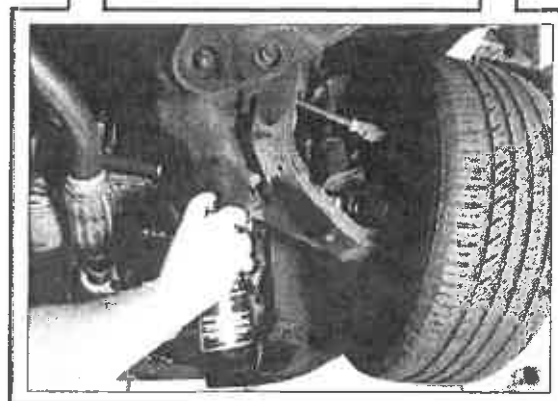
2. Apply undercoating onto the upper and lower surfaces of each front lower control arm. Avoid spraying unrelated parts of the vehicle.

Additionally, on all vehicles, apply undercoating to the brake line mounting brackets, as shown below.

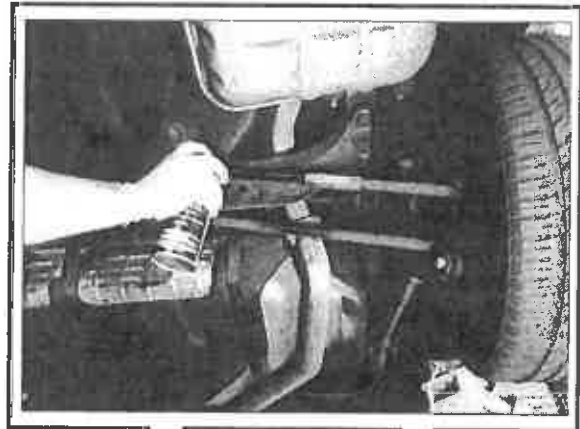
1. On Spectra (LD) vehicles, apply undercoating onto each rear lower control arm and trailing arm. Avoid spraying other unrelated parts of the vehicle.

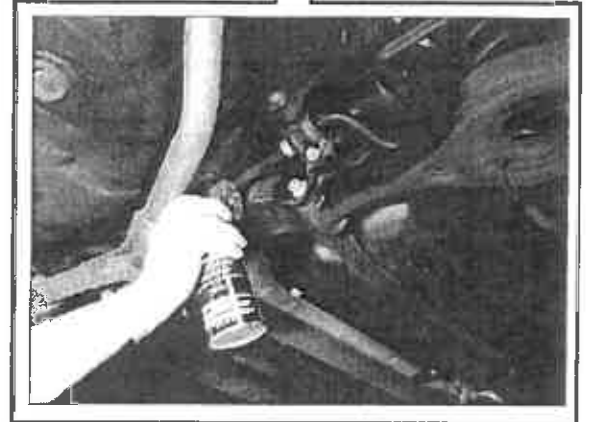
4. Apply undercoating onto the entire rear cross member, as shown. Do **NOT** apply undercoating to the exhaust pipe or other unrelated parts of the vehicle.

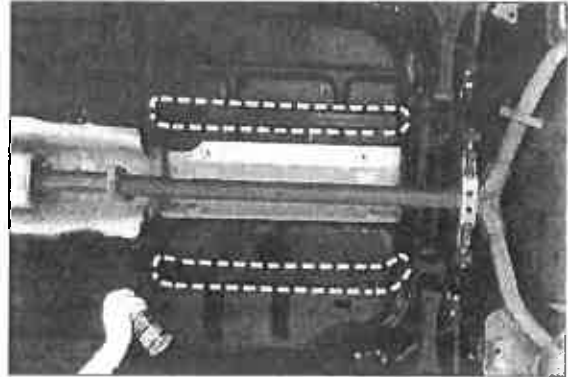
2. On Optima (MG) vehicles, apply undercoating to the fuel tank straps, as shown below.
